DECORATIVE POND INSTALLATION

The Installation: Disinfection of a Pond size 53m² with a volume of 16m³ of water in front of an office building.

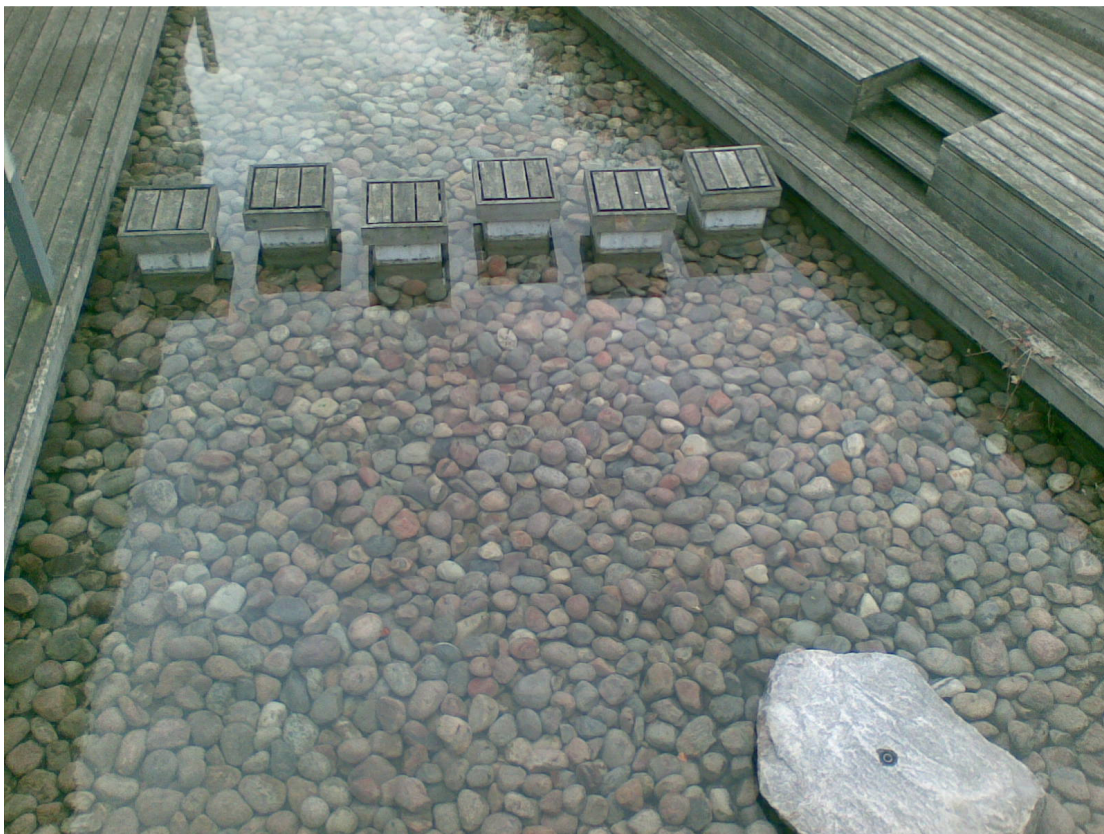
The Pond

The pond had become heavily infested with Algae and was an eyesore in addition the oxygen levels in the pond had fallen due to anaerobic bacterial activity creating an unpleasant smell.

A 40 liter generator was installed dosing directly into the pond to achieve an ORP in the 450-500 mv range this required the unit to run for 4 hours (160 liters) per day initially due to the high biological load. After 3 months the level of dosing was reduced to 2 hours per day (80 liters Neuthox)

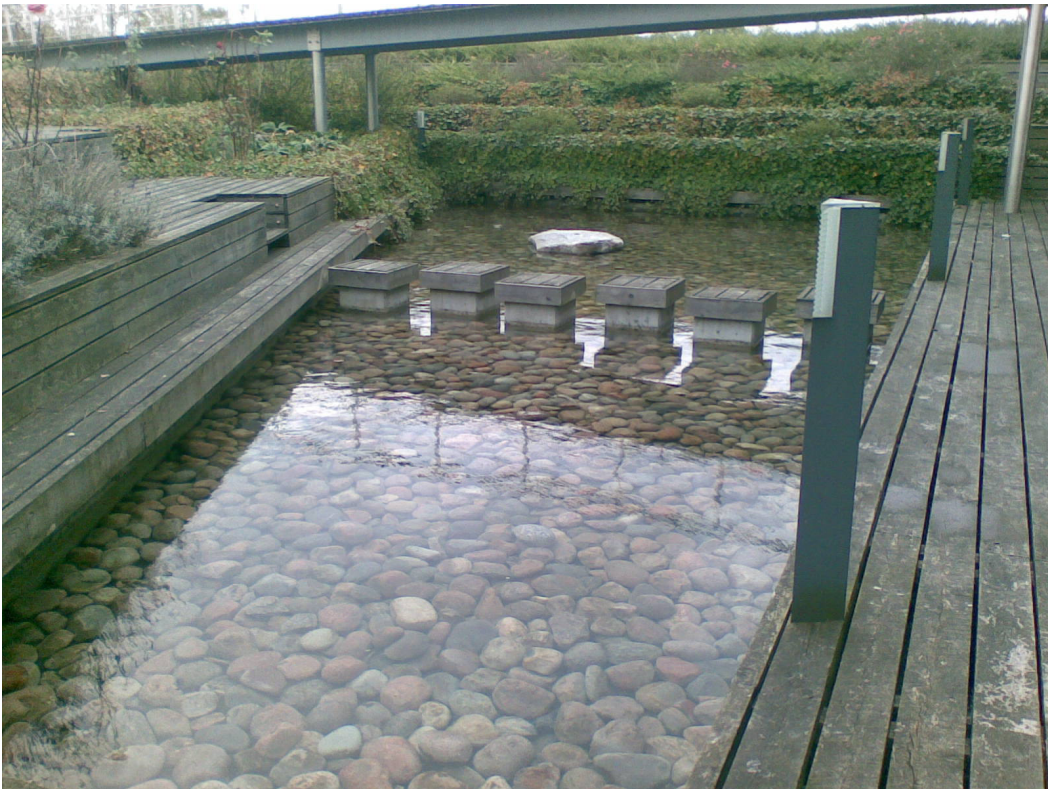
After - treatment

As can be seen from the after picture the pond now remains clear of algae – and as the kitchen staff said, “Even the frogs coming back now!”

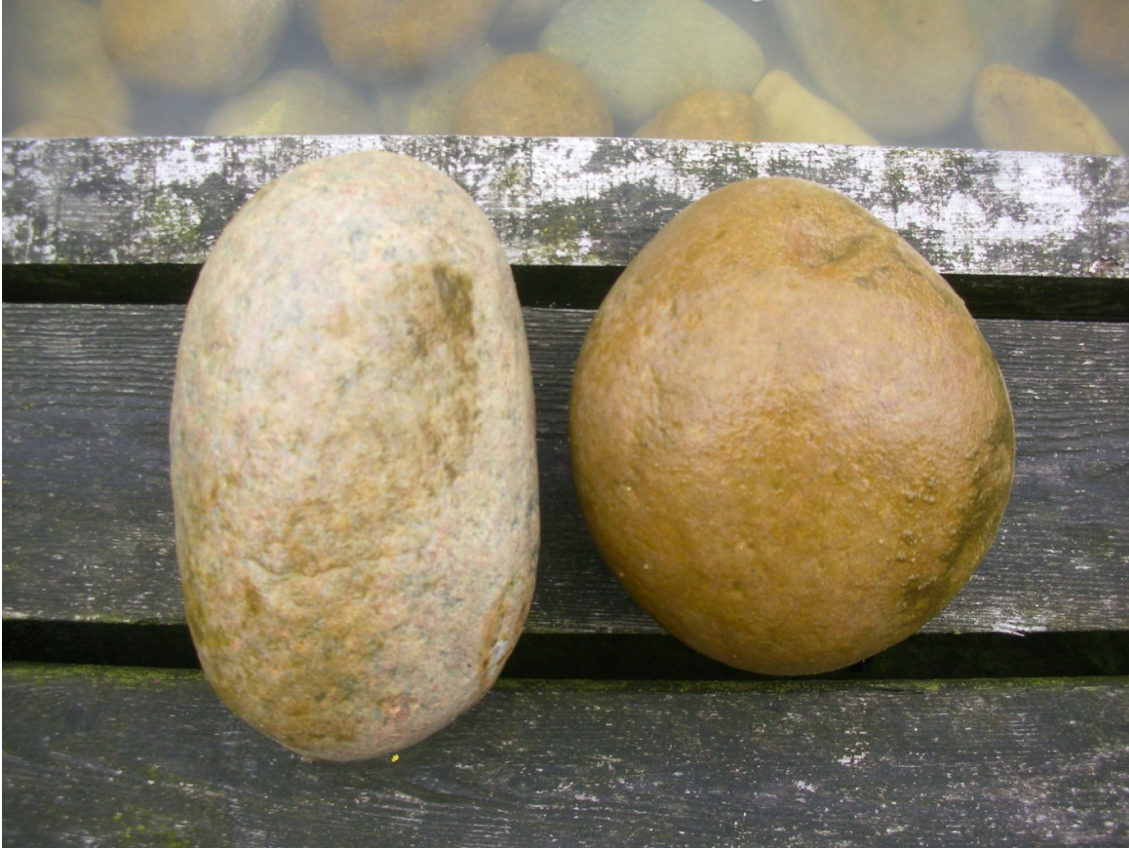
The picture below shows stones with a layer of algae.
